REPORT TO COUNCIL ON PLAYGROUND SAFETY:

The Need for Replacement and Renovation

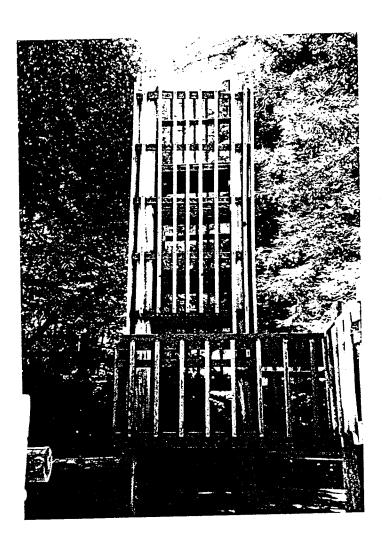
La Loma Tot

Site-built climbing structure <u>far</u> exceeds safe height (potential 20 foot fall). Potential for head trap between top rails; lower rails inadequate. Climbing structure is constructed with nails rather than bolts. Rotting plywood elements.

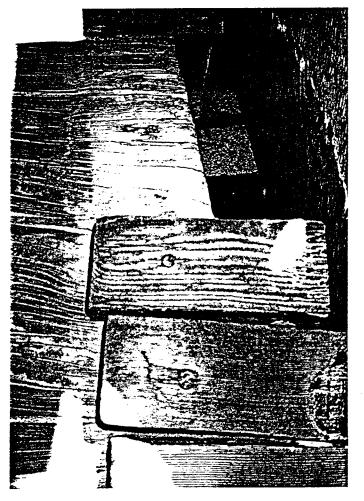
Closeup of rotting wood, exposed nails, and unstable elements of train. Train is poorly designed and unstable; can easily be rocked from side to side. Considerable wood rot, exposed nails, missing pieces.

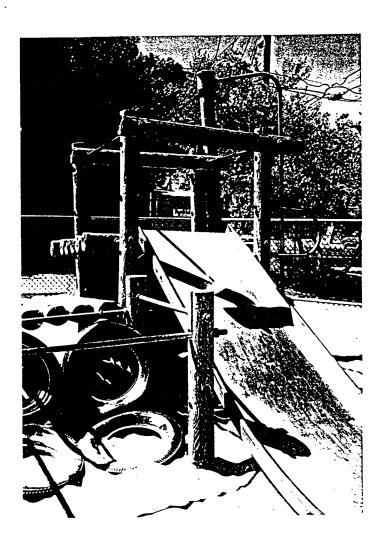
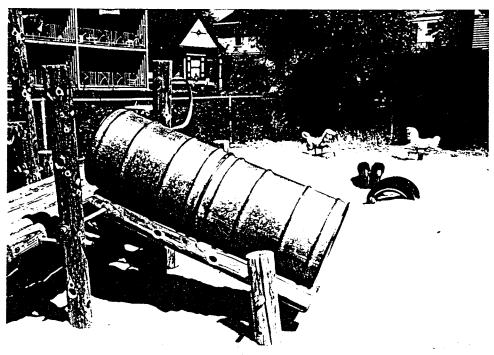
Ohlone Tot East

Extremely worn and rotting wooden play structure. Non-compliant components of play structure. Protruding bolt in slide path. Spring animals sunken and tilted. Leftover tires.

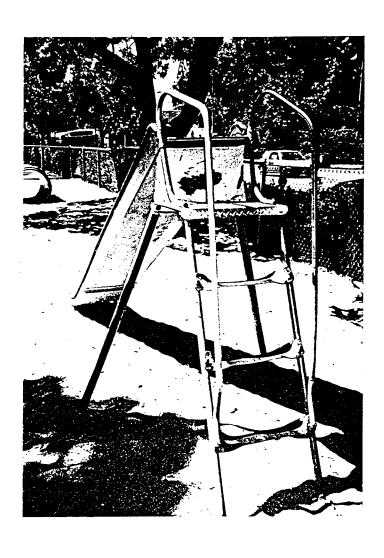
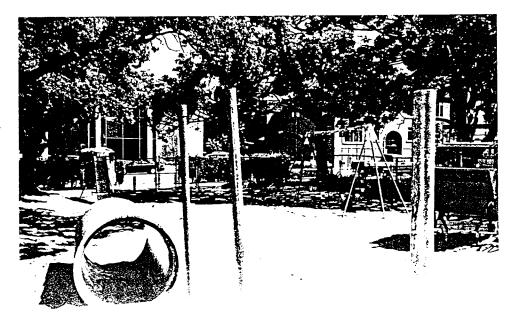
Martin Luther King Tot (aka Civic Center Tot)

All equipment is extremely worn. Slide is a nonconforming design, steps are bent and slippery; inadequate fall zone. Poor layout.
